**DEPARTMENT OF TRANSPORTATION**

Contract #: 04-0120F4Cty: SF/ALA Rte: 80 PM: 13.2/13.9File #: 1x.28**WELDING INSPECTION REPORT****Resident Engineer:** Pursell, Gary**Address:** 333 Burma Road**City:** Oakland, CA 94607**Report No:** WIR-016036**Date Inspected:** 29-Jul-2010**Project Name:** SAS Superstructure**OSM Arrival Time:** 700**Prime Contractor:** American Bridge/Fluor Enterprises, a JV**OSM Departure Time:** 1100**Contractor:** American Bridge/Fluor Enterprises, a JV**Location:** Job Site**CWI Name:** John Pagliero**CWI Present:** Yes No**Inspected CWI report:** Yes No N/A**Rod Oven in Use:** Yes No N/A**Electrode to specification:** Yes No N/A**Weld Procedures Followed:** Yes No N/A**Qualified Welders:** Yes No N/A**Verified Joint Fit-up:** Yes No N/A**Approved Drawings:** Yes No N/A**Approved WPS:** Yes No N/A**Delayed / Cancelled:** Yes No N/A**Bridge No:** 34-0006**Component:** OBG Section**Summary of Items Observed:**

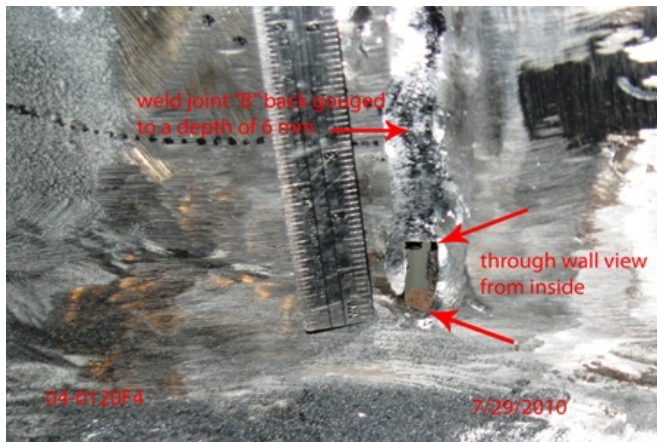
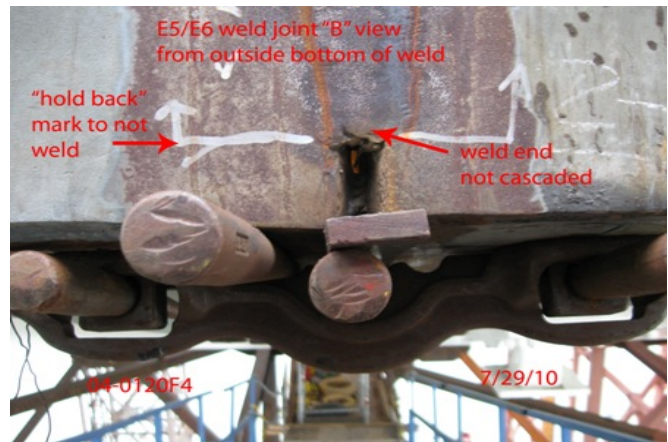
3) At 5E/6E-B: A variation from previous methods of welding this joint were observed.

At weld joint E5/E6, inside the OBG section, the previous day this QA Inspector had randomly observed ABF personnel setting up to back gouge weld joint E5/E6-B, but observed the work had not started during this QA Inspector's shift. This QA Inspector observed back gouging had been performed and during a random visual verification observed the following: an area approximately 12 mm in length and 6 mm wide where the back gouging process had removed all weld metal creating a hole through thickness. See photos below of area both inside and outside. Previously ABF personnel had completed the weld joint "B" prior to welding joint "C". It appears ABF has elected a change by not completing weld joint "B" prior to welding joint "C". Please notice the "hold back" or "do not weld" marks on the face of joint "B" on the photo from the outside. This QA Inspector also observed the weld termination had not been cascaded to facilitate further welding. This QA Inspector observed this condition at the following locations: E5/E6-B, E5/E6-F, E4/E5-B and E4/E5-F. This QA Inspector asked Lead QC Inspector Mike Johnson and QC Inspector Steve McConnell if there were aware of this issue and of the proposed method of completing weld joint "B" now that a through wall hole was present. Both QC Inspectors acknowledged they were aware of the change and issues, but that ABF had not informed them of the proposed method to complete the weld joint. QC Inspector Steve McConnell stated a typical condition existed at several locations on the West OBG sections. This QA Inspector brought the issue to the attention of onsite Lead QA Inspector Rick Bettencourt and was informed the information regarding the condition had been passed onto Lead QA Inspector Bill Levell.
